# **Incident Learning: Contained Deflagration**

**3 May 2018**

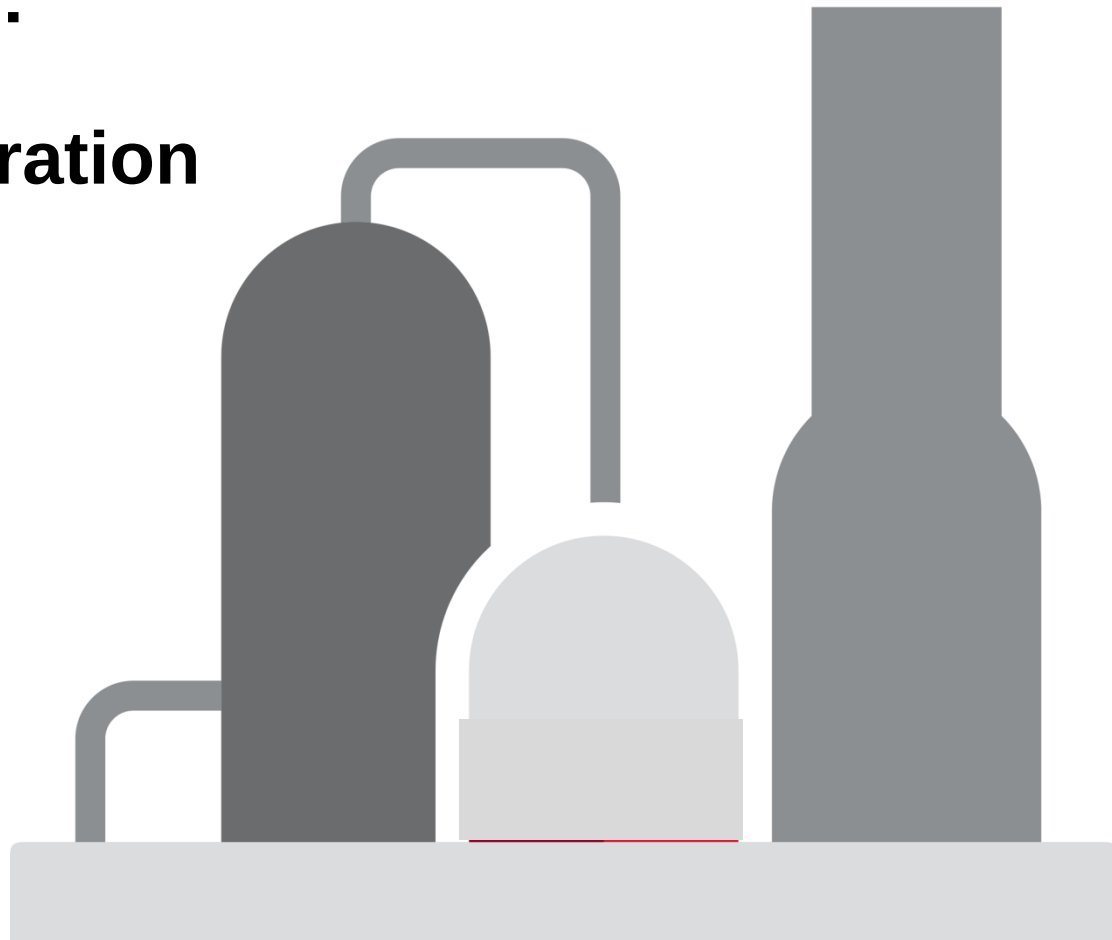
# Platformer Flow Diagram

PLATFORMER : PLANT 4

REGEN MONITORING

HSR FROM 71C - 17  
VIA 3E - 4

DIH BOTTOMS  
FROM 71C - 14

FEED

REACTOR CIRCUIT

HYDROGEN RECYCLE

STABILIZER

DEBUTANISER AND DE - ETHANISER

MEDIUM  
PLATFORMATE

HEAVY  
PLATFORMATE
