# Incident Learning: What happened?

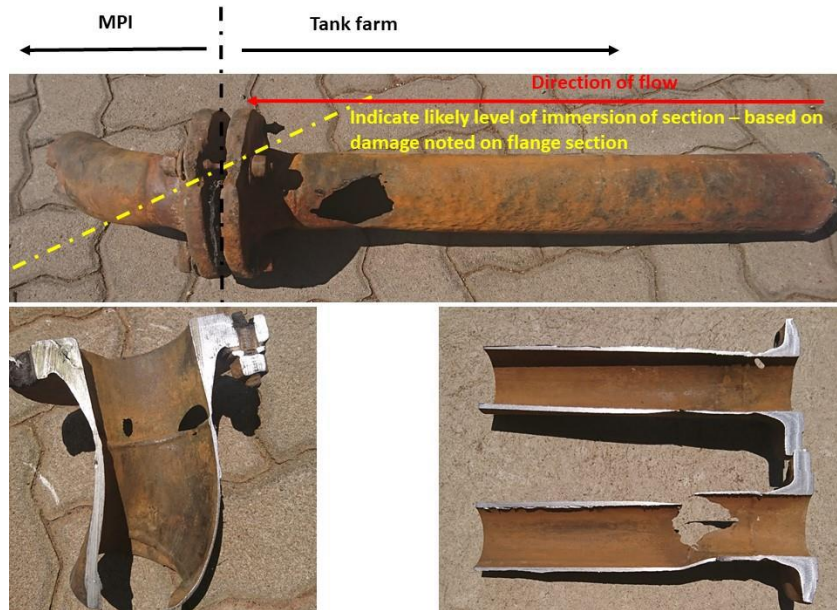
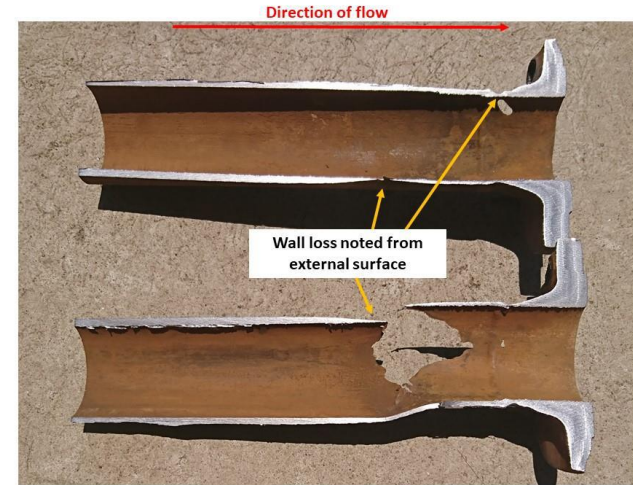
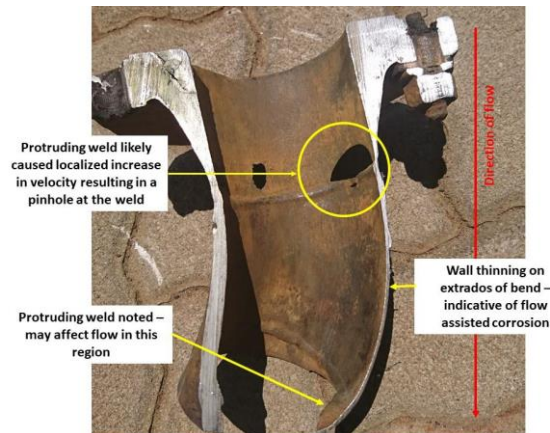
# Photos of damage piping

- Sulphuric acid was released from a pinhole of a pipeline in the pipe rack. Rain water accumulated in the culvert that aggravate the corrosion rate to other pipelines.
- The product corroded other pipelines in the vicinity that resulted in a loss of containment of other material (fuel oil, high organic waste, utility water, pumped condensate return, phenolic pitch, crude phenols and caustic soda ) from the pipelines.
- Root cause:
  - Maintenance strategy inadequate as the flange neck was not inspected based on historical results.
  - The accelerated, localised corrosion on the weld could not be detected or prevented by the current maintenance strategy.
  - Corrective, preventative action or closure of corrective action not yet implemented.

- Lack of flow rate monitoring or control with regard to the use of the sulphuric acid system. Sulphuric acid system was designed and installed with limited measuring devices like flow meters to measure and control transfer rates.
- Higher rundown temperatures resulting in accelerated internal corrosion rates after the Wet Sulphuric Acid (WSA) plant was incorporated into the existing sulphuric acid system.
- Not all the hazards, risks and controls associated with accelerated, localised corrosion in the pipeline were identified and understood (.i.e. presence of protruding weld roots).
- Replace the carbon steel piping with PTFE lined piping has already commenced.
