OME SHE Learning

Learning number FY24-06 (Potential HSI)

Operating Entity Natref

Key Undesirable Event Person falling from elevated position.

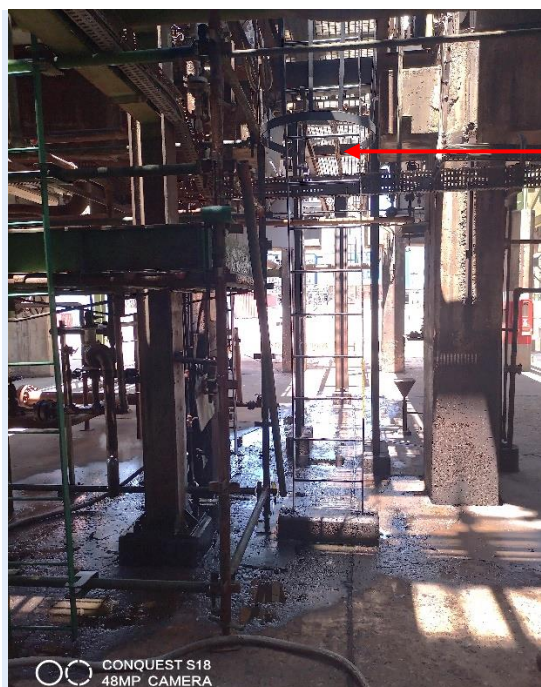
Description of the incident A learner process controller descended a cat ladder at F15002 with a donned airline mask. She lost control of her descent and fell approximately two meters to the ground. She fractured the right femur (thighbone).

Area where IP was standing when she lost control.

1. When assigning duties to employees, especially learner employees, ensure that the employee is comfortable and confident to do the job on their own when doing it for the first time. Even though declared competent.
2. Ensure that cat-ladders and walkways are clear from any obstructions. Learner employee most probably stepped on the wrench which she hanged on the cat ladder rung.
3. Good practice for climbing cat-ladders must always be applied, i.e., hands free, and one foot stepping on middle of the foot.
4. To ensure proper hand grip that the nails (including artificial nails) of employees who are required to wear gloves when climbing cat-ladders must be cut short to fingertips length.
