# Learnings From Incident- **CABE System Failure** **Cleaning Tank C-10**

# CABE System Failure Cleaning Tank C-10

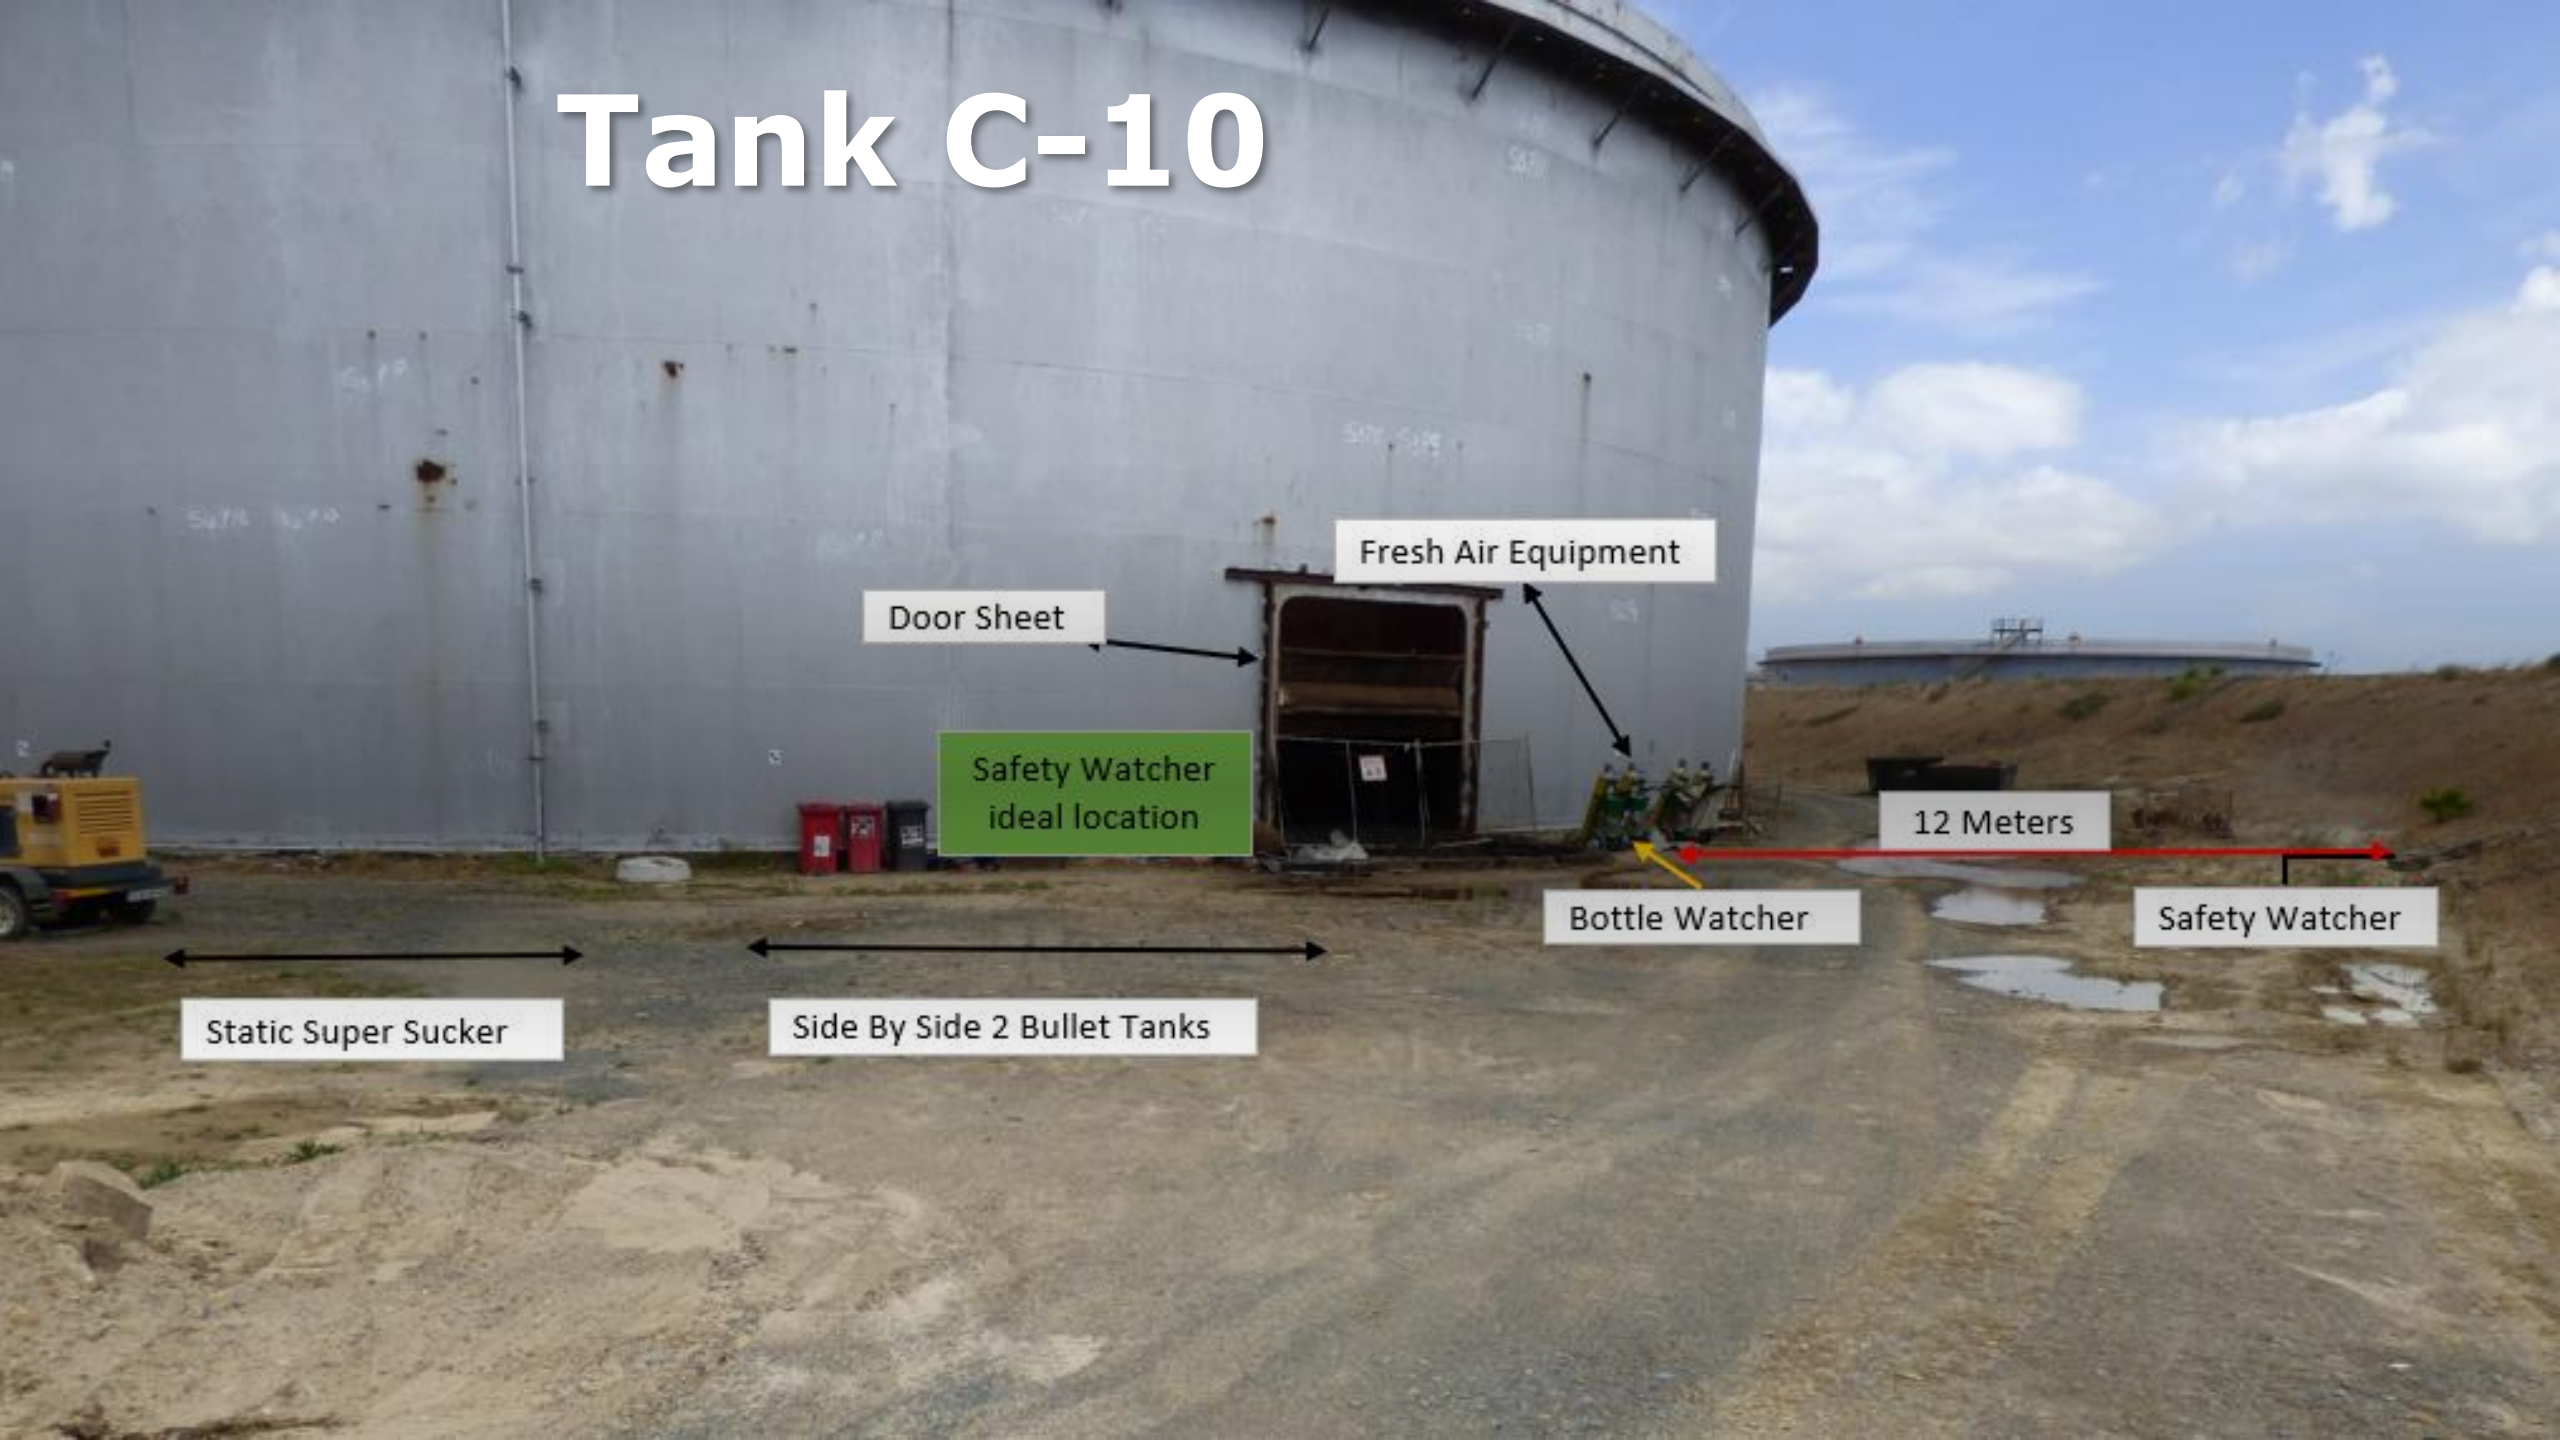
# Tank C-10

Fresh Air Equipment

Door Sheet

Safety Watcher  
ideal location

12 Meters

Bottle Watcher

Safety Watcher

Static Super Sucker

Side By Side 2 Bullet Tanks
