Incident Learning: What happened?

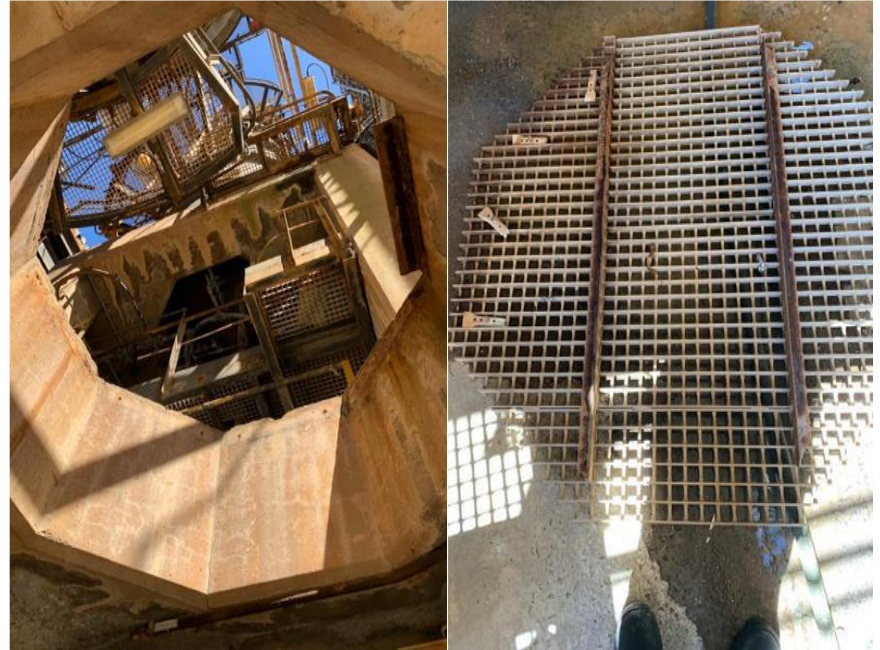
- At around 10 AM on 12th March 2023 a piece of mentis grating fell from approximately 4 meters high as it came adrift and fell to grade on Plant 53 FCC structure.
- The Plant 53 operator was busy dipping the fresh catalyst hopper and had to step over the mentis grating to close the air valve to prepare to dip the fresh catalyst hopper, 53C-202.
- As the plant 53 operator was stepping over the mentis grating, with one foot on the concrete slab which supports the mentis grating, the grating came adrift and fell 4 meters to grade.
- No one was injured.

- Report all incidents to your Supervisor and submit a work request for any damaged railings, gratings and stairways for repairs to be conducted as soon as possible.
- Ensure areas that have damaged, or missing railings and gratings are barricaded to prevent access and possible injuries to others.
