# Incident Learning: What happened?

Injured person (IP) was stepping down from a bund and twisted his ankle resulting in a fracture (LTI).

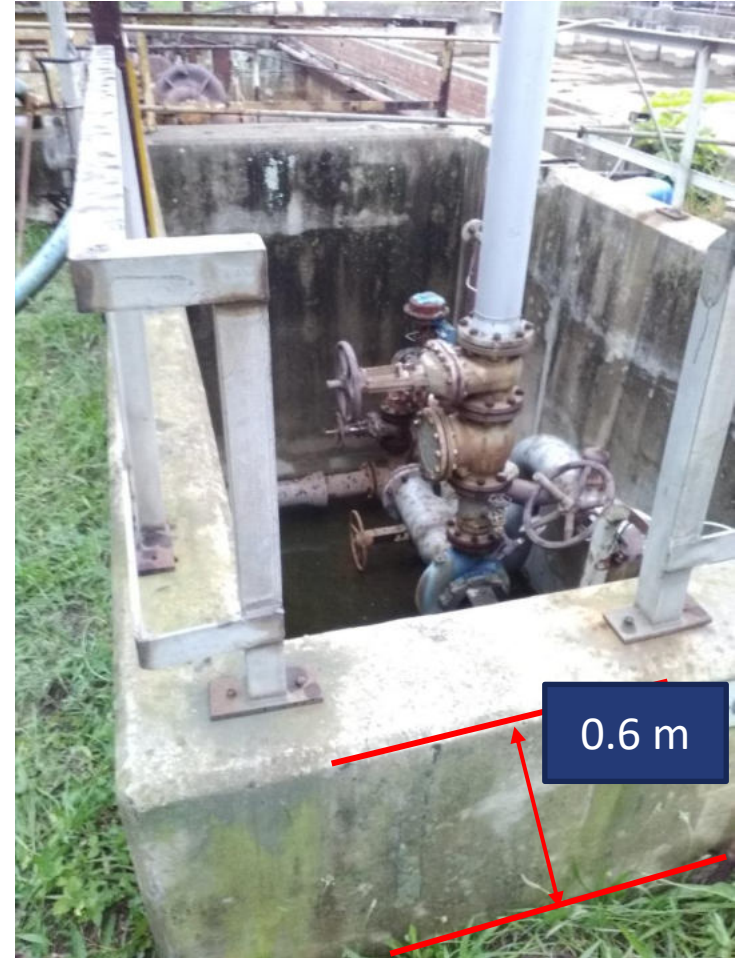
The employee climbed up the bund wall, holding the rails on the sides. When he was attempting the 180 degree turn to enable descent into the valve pit, he realized he was not positioned correctly to turn safely. So, he decided to go back down and restart. Restarting meant stepping back outside the pit. It was during that process that his foot hit the ground in the wrong orientation leading to the ankle fracture.

- The valve is recessed into the pit, which necessitates climbing into the pit every time it needs to be operated.
- It is possible to raise it along the pipe such that it is at ground level and put grating to close the pit so that it can be operated while standing on the grating. An access hole can be placed to allow for less frequent maintenance access into the pit.
- The inside of the pit is 3.4m deep with no support to prevent accidental falls from the top
- A grating that can be opened to enter the pit can be installed for non-routine maintenance and special circumstances.
