# MTC – Finger Injury - 20<sup>th</sup> July 2019

## **Brief description of Event:**

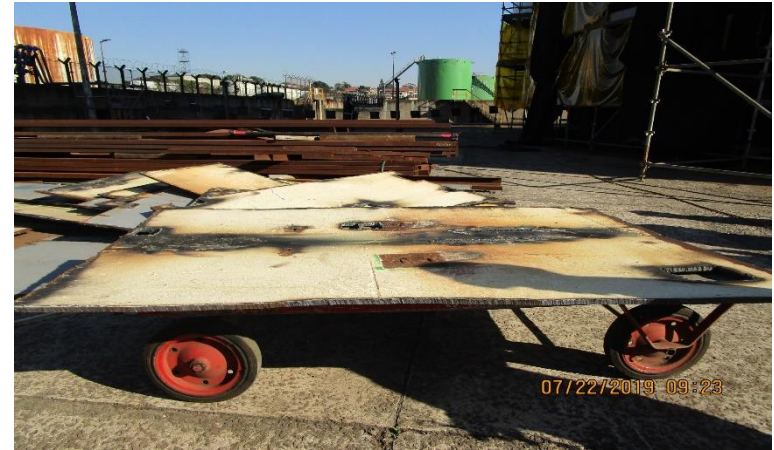
A piece of steel plate had been cut off the floor of the tank and was lifted using chain blocks onto a trolley. A cable became stuck under the plate on the trolley so three employees lifted the plate to remove the cable and in the process, the plate was dropped (slipped) on one which resulted in an employee's hand being caught between the plate and his Safety Boot. The steel plate had a sharp edge after it was cut off the floor of the tank and the incident happened 1hr before end of shift and this was weekend work. The worker sustained a cut on the inside of his right hand pointing finger. He was wearing level 5 cut resistant gloves. He received first aid at the Sapref clinic and the clinic sister applied 4 stitches to close the wound. This has been classified as a Medical treatment case (MTC). Investigation is in progress

The risks pertaining to the task was not properly discussed. The LMRA highlighted nip and pinch points however it did not specifically highlight the hazards of lifting the heavy plate

Trolley with steel plate

- Heavy equipment should be rigged using the proper equipment instead of manually lifting.
- Chocks to be used under plating when lifting
- Area to be checked for fouling before setting the plates down
- Discussion to be held before executing any task
- LMRA to be specific all the hazards and risks of the task
