# Incident Learning: What happened?

## 1. BRIEF DESCRIPTION OF EVENT

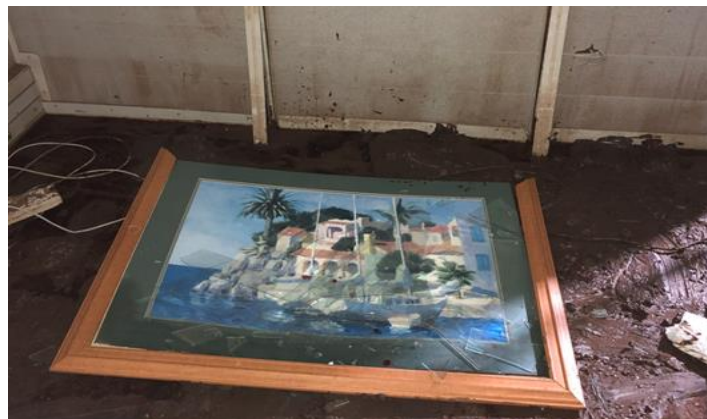
## 3. SKETCH/PHOTOGRAPH

On 10<sup>th</sup> May 2022, an employee was assisting with clean-up activities in offices following the flood damage on the 12<sup>th</sup> April 2022. Whilst removing a picture frame from the wall, the glass on the frame fell off and hit the person on the forehead. The glass broke off on impact, causing three cuts on the forehead and one above the right eye. The cut above the right eye was deep and pierced through the skin to the top of the eyeball, resulting in a cut in the eye. The injured person received first aid treatment at the clinic and was sent to hospital for further assessment. The cuts were stitched, and the person was seen by an eye specialist and will undergo eye surgery. The person is doing well and has sight on the injured eye. The person was wearing PPE and eye protection (safety glasses) at the time of the incident.

- LMRA for the task did not identify the risk of falling objects .
- The frame was partial submerged in water which compromised it's integrity.

1. All areas to stop work and have a stand down to discuss the incident and identify any other hazards due to compromised structures.

- Identify all potential hazards during the LMRA and implement the required mitigations.
- Do not put yourself in the Line of Fire
- Construction materials e.g.. Frames may be compromised and require special handling.
- Remove items that are hanging on the wall inside offices e.g. frames, etc. before starting clean-up activities.
- Hard Hat to be added as mandatory PPE during the clean up activities.
