# Incident Learning: What happened?

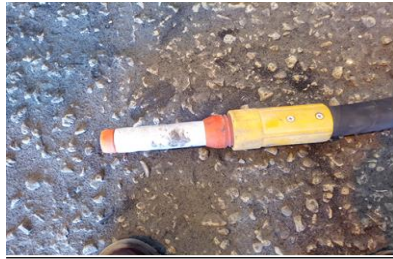
Photo of hose with complete fitting, nozzle holder intact

- Sandblasting nozzle holders must frequently be inspected and maintained to ensure that they are in good working condition.
- Ensure that the sandblasting pots from services are properly flushed out to remove any residual blockages or any foreign objects that may have been accidentally left in the pot or hoses.
- Employees need to be trained on all parts of the equipment they are exposed to.
- All procedures and risk assessments must incorporate control measures aligned with service provider and clients' guidelines.

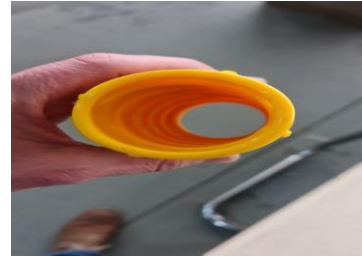
New Nozzle holder inside,  
Description: round tube of hardened polyurethane plastic, not designed to keep pressure, it goes over the blast hose with screws and the nozzle turns inside

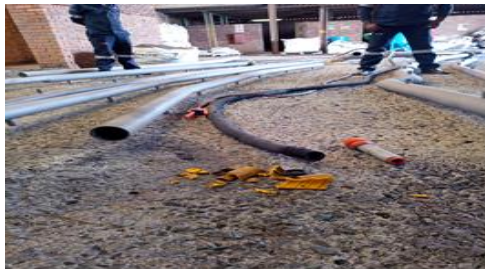
- While busy sandblasting a pipe, the blaster noticed that there was no grip coming out of the nozzle, he communicated to the pot operator (by waving) to check what was the problem. The pot operator followed the procedure and pumped the pot to get the flow of the grit flowing again. While the sandblaster was still holding the blasting hose in position to continue blasting, the fixed nozzle holder ruptured, the nozzle was pushed by the pressure from the hose. The hose fell down, ricocheted and hit the blasting helmet causing injury to the employee, resulting in lacerations to upper and lower lips.

Photo of dislodged Nozzle and ruptured nozzle holder

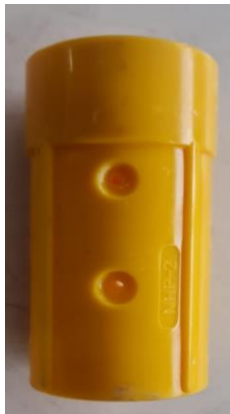
Nozzle holder where screws are fitted (by supplier and delivered on the hose)
